NASA Contractor Report 191188

Insoluble Coatings for Stirling Engine Heat Pipe Condenser Surfaces

Peter M. Dussinger
Thermacore, Inc.
Lancaster, Pennsylvania

September 1993

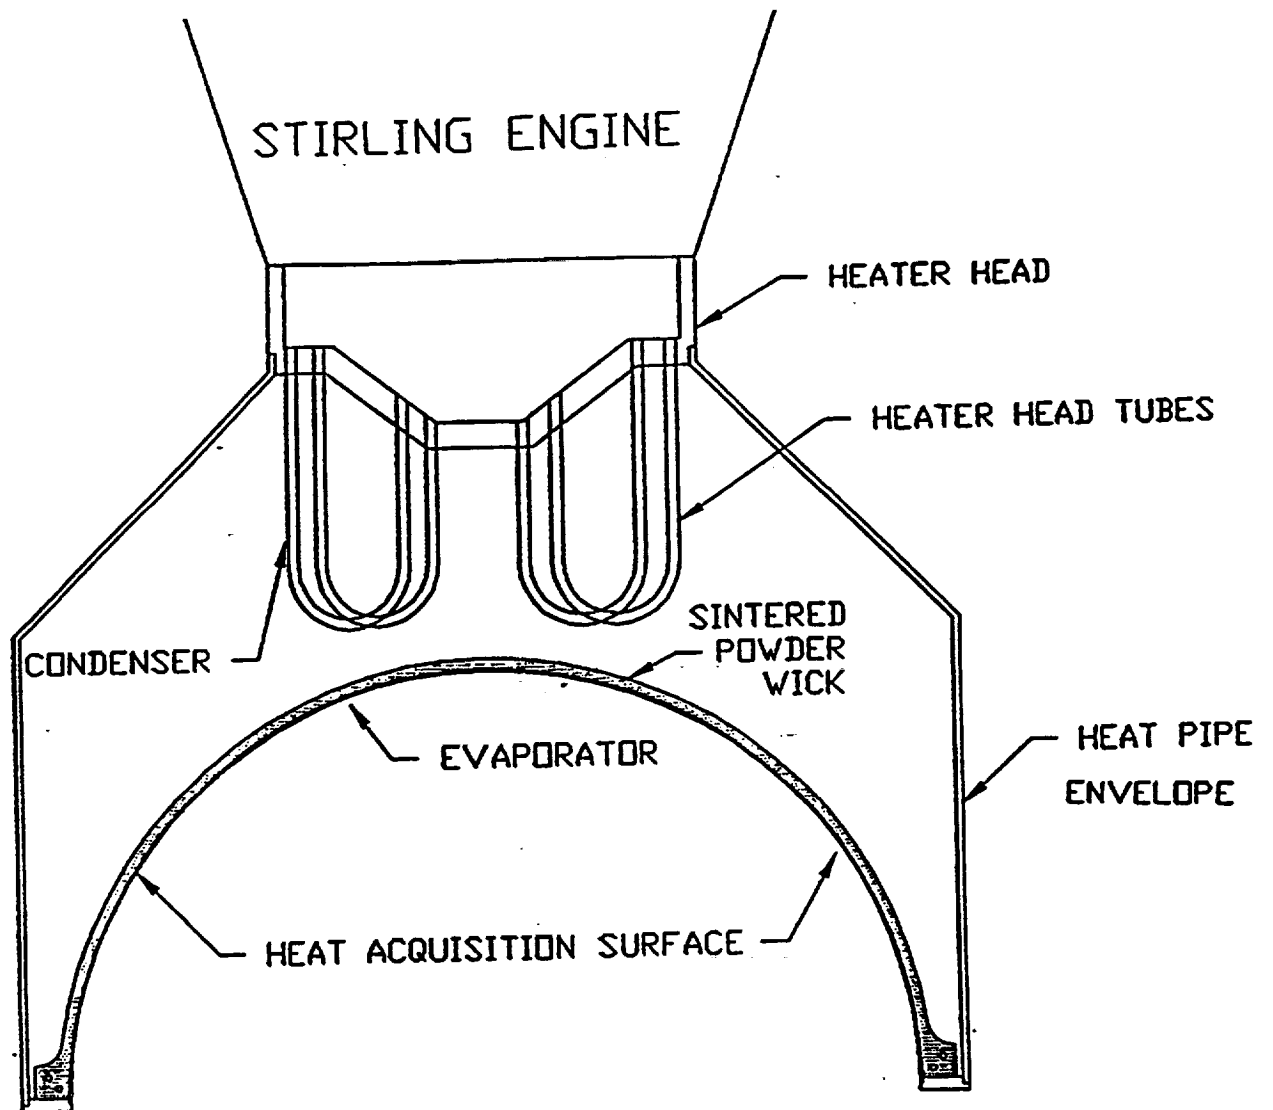
FIGURE 1. STIRLING ENGINE HEAT PIPE SOLAR RECEIVER

Dish Stirling systems are one of the most promising applications of the Stirling engine technology. Solar energy is concentrated by a parabolic reflector and is directed to the heat input section of the Stirling engine. The heat input section typically consists of a series of small diameter (5-8 mm) tubes that contain the engine working fluid, hydrogen or helium, as it shuttles between the expansion space and the cooler. It has been shown both analytically and by test, that the optimum engine efficiency results when the heat acquisition section is heated at a uniform temperature. The engine hot end typically operates at 550-800°C. Therefore, the optimum engine efficiency results when all of the heater head tubes are operating uniformly at 550-800°C. A liquid metal heat pipe receiver is typically utilized for this purpose. Figure 1 is a sketch of a typical heat pipe solar receiver for planetary use. A variation of this type of receiver can also be produced for use in space (zero gravity).

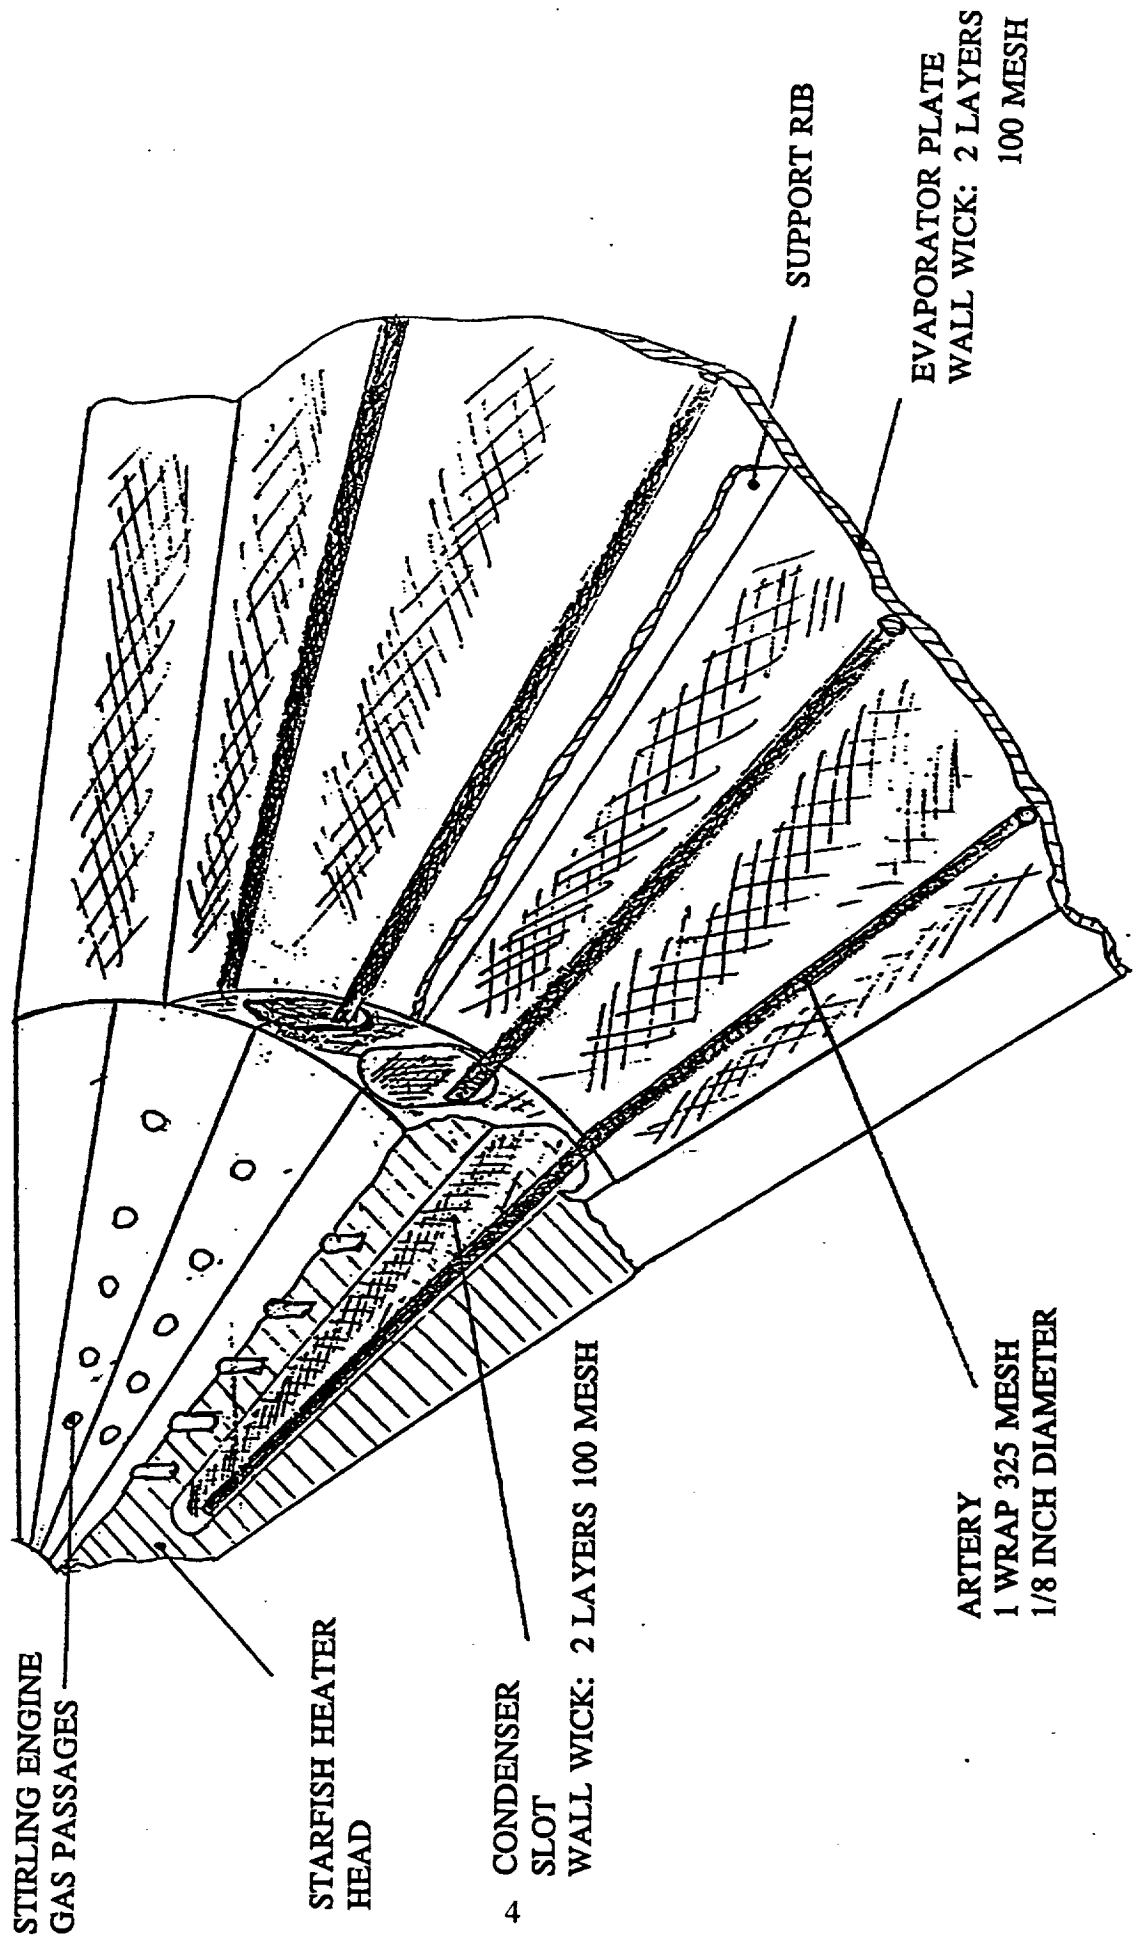
FIGURE 2. NUCLEAR REACTOR/STIRLING ENGINE HEAT PIPE RECEIVER

Nuclear Reactor/Stirling Engine Systems are also being developed for electrical power generation for use in space. In this application, the nuclear reactor is typically cooled with a liquid metal pumped loop. The pumped loop is thermally coupled to the Stirling engine by a heat pipe receiver. One example of this type of receiver is shown schematically in Figure 2. In this example, the heat acquisition section consists of solid metal fins with internal helium or hydrogen passageways. As mentioned previously, the optimum engine efficiency results when the heat input fins are heated at a uniform temperature of 550-800°C. Therefore, liquid metal heat pipes are used to transfer the heat from the reactor primary cooling loop at a uniform temperature to the heat input fins of the Stirling engine.

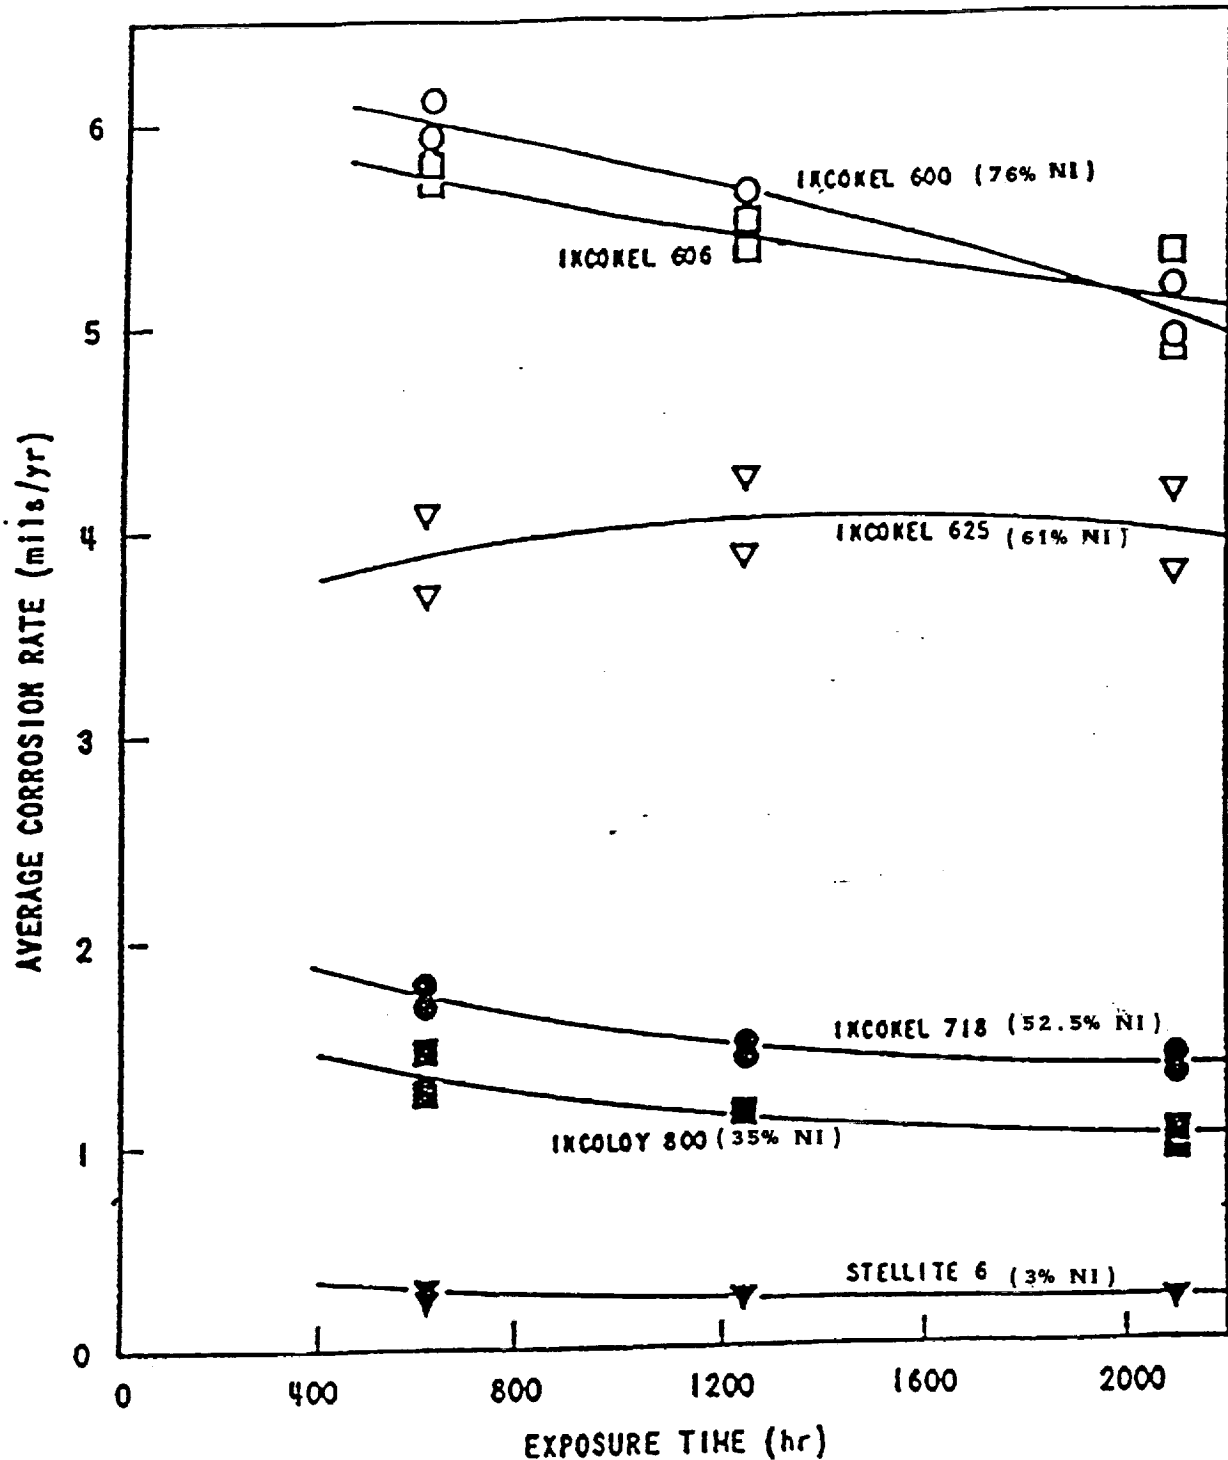
FIGURE 3. AVERAGE CORROSION RATE FOR NICKEL BASED ALLOYS
IN PUMPED LOOPS

Solubility corrosion has the potential to be responsible for a number of premature failure mechanisms. Figure 3 is a plot of solubility corrosion rate versus time for a few nickel based superalloys subjected to flowing sodium at 720°C in a pumped loop. The corrosion rates

reported are 25-127 $\mu\text{m}/\text{year}$ (1-5 mils/year). Assuming a similar mechanism as that in a pumped loop, the wall thickness of a heater head tube or fin could be reduced by .25 - 1.27 mm (.010 - .050 inches) in ten years. In some cases this corrosion depth is greater than the starting wall thickness and in most cases the depth of corrosion is at least 50% of the starting wall thickness. Another potential failure mechanism is plugging of the heat pipe evaporator wick structure with the precipitated heater head material. Heat pipe wick structures typically have pore sizes of 1×10^{-5} m. Partial plugging can cause high liquid flow pressure drops that exceed the wick pumping capability which results in a dryout situation and potential melting of the receiver envelope.

A general trend for nickel based superalloys in pumped loop environments, which can be seen in Figure 3, is that higher nickel concentrations resulted in increased corrosion rates. This is only a trend and exceptions can be found. The other constituents, such as chromium, iron, molybdenum, columbium, aluminum, etc. are also soluble in sodium, potassium, and NaK. The literature suggests that iron is particularly susceptible to corrosion if the oxygen content of the liquid metal is high ($> 10\text{ppm}$). Precipitation hardenable alloys are particularly susceptible to selective corrosion of the grain boundary materials. If this condition occurs the material may crack along the grain boundaries and cause failure of the pressure boundary.

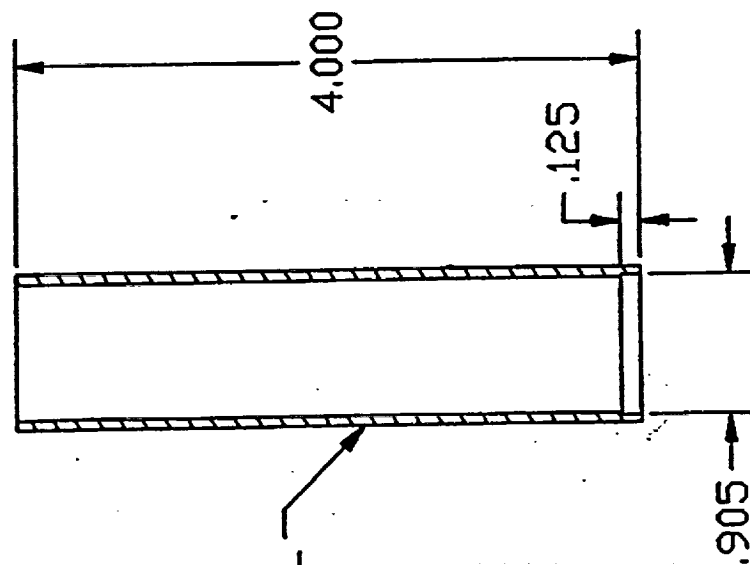
As stated in Section 2.1 Requirements, it was determined jointly by Thermacore and NASA LeRC personnel that a total of six sample tubes would be prepared for solubility corrosion testing. Three tubes would be Nickel 200 and three would be Nickel 200 with a nickel aluminide coating. Based on the condensation heat flux and the typical dimensions of a Stirling engine heater head, the sample tubes were chosen to be 25.4 mm (1.0") diameter x 1.65 mm (.065") wall x 101.6 mm (4") long. The sample tube and endcap drawings are shown in Figure 4. The endcaps were gas tungsten arc welded (GTAW) into the tubes.

SAMPLE TUBE

SAMPLE TUBE ENDCAP

MATERIAL: NICKEL 200

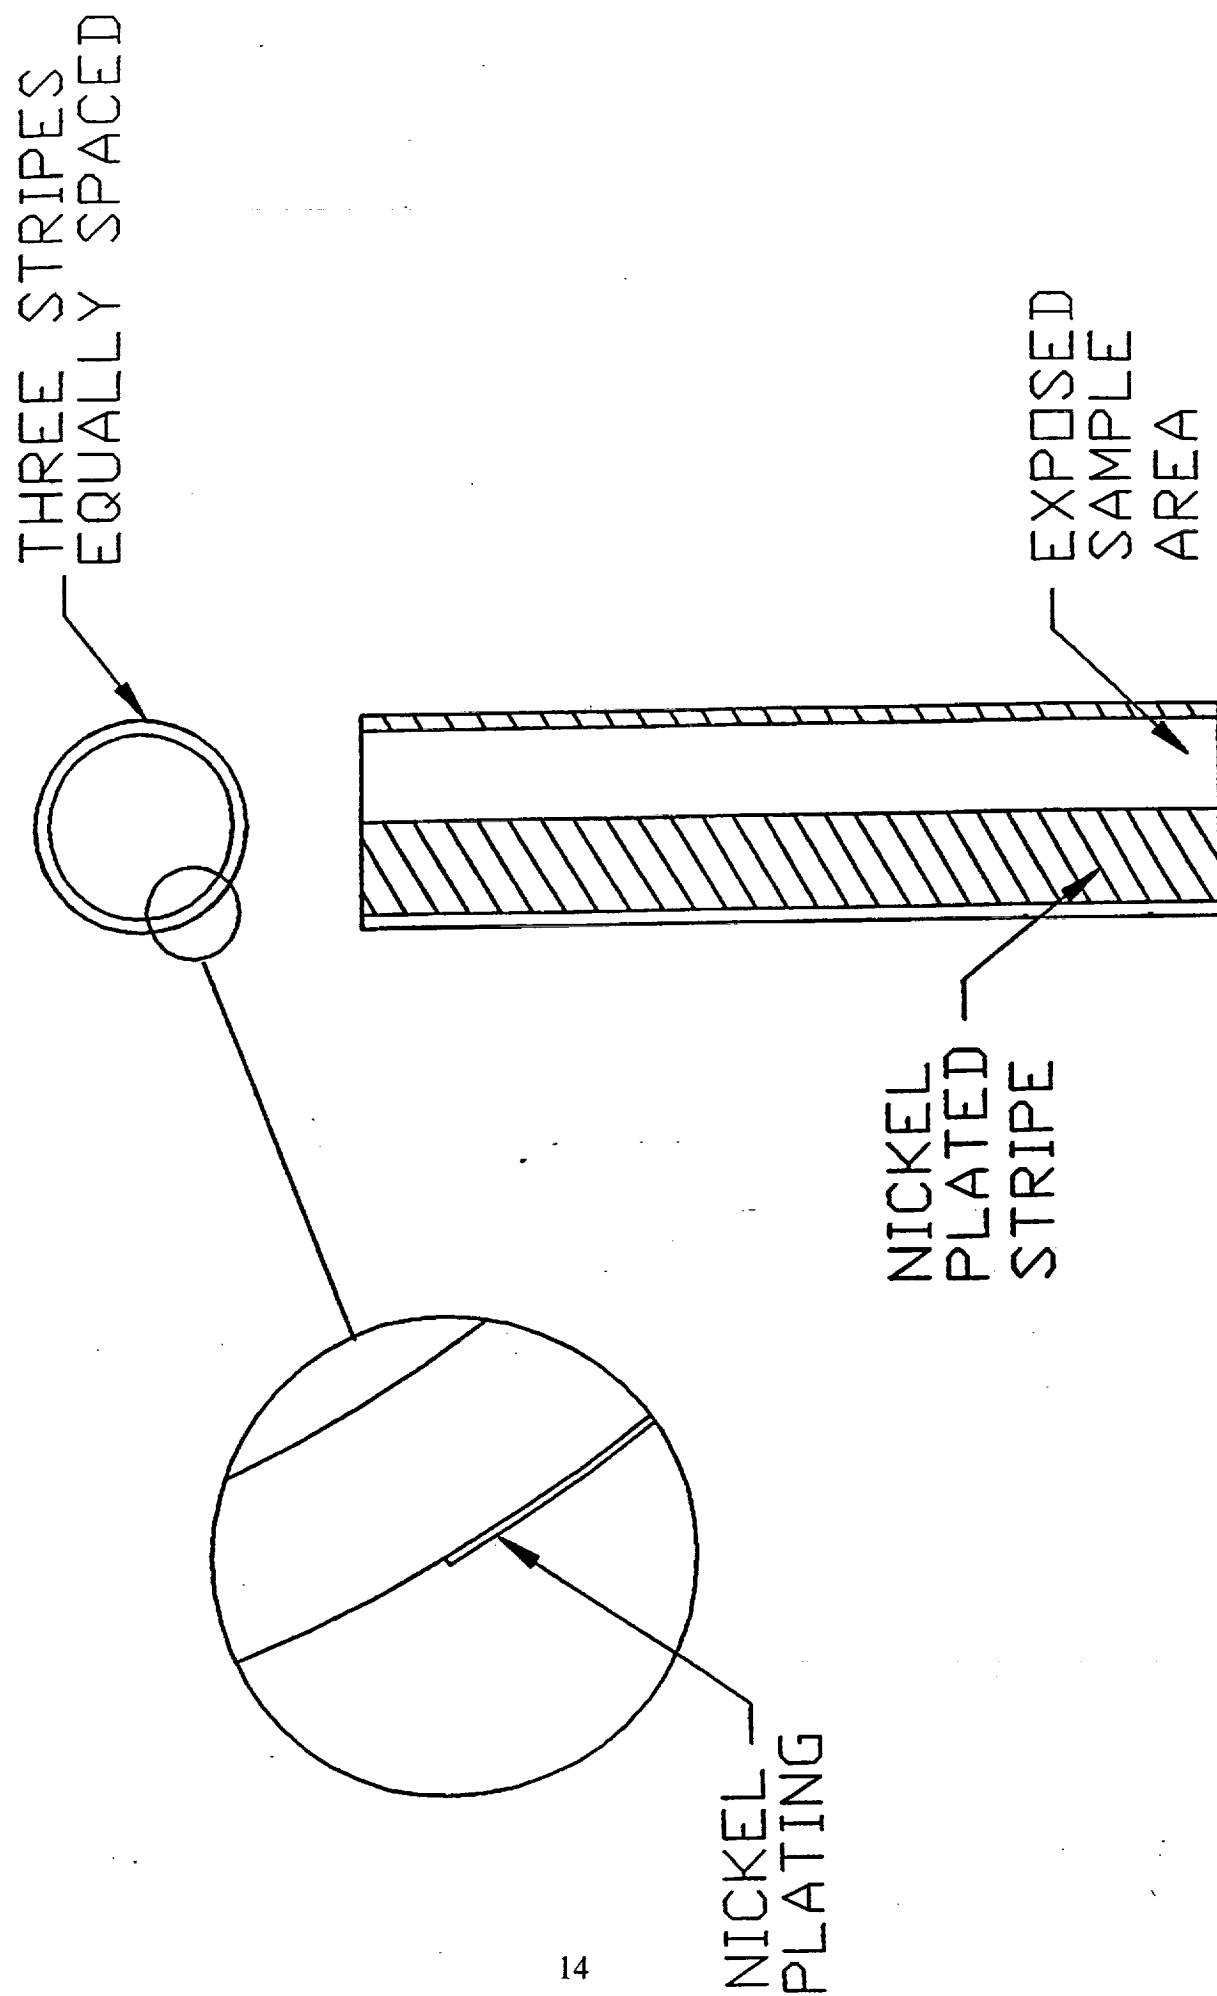
FIGURE 5. STRIPED NICKEL PLATING CONCEPT

Scaling from photomicrographs at high magnification, 50 to 400X, can be used to accurately determine the depth of corrosion. For example, at 200X magnification $2.5\text{ }\mu\text{m}$ (.0001") of corrosion is .5 mm (.020") which is easily measured with an accurate flat scale or dial calipers. In order to make the measurements, a base measurement location must be preserved. One technique that can be used to preserve the base measurement location is to nickel plate stripes onto the sample tubes. The nickel plating stripes are applied axially, in the direction of gravity draining and protect the underlying surface from solubility corrosion. The nickel plating thickness was selected to be $76.2\text{ }\mu\text{m}$ (.003"). The nickel plating stripe must be thick enough such that the plating will not be completely dissolved during the 1000 hour test. Figure 5 illustrates the striped nickel plating concept.

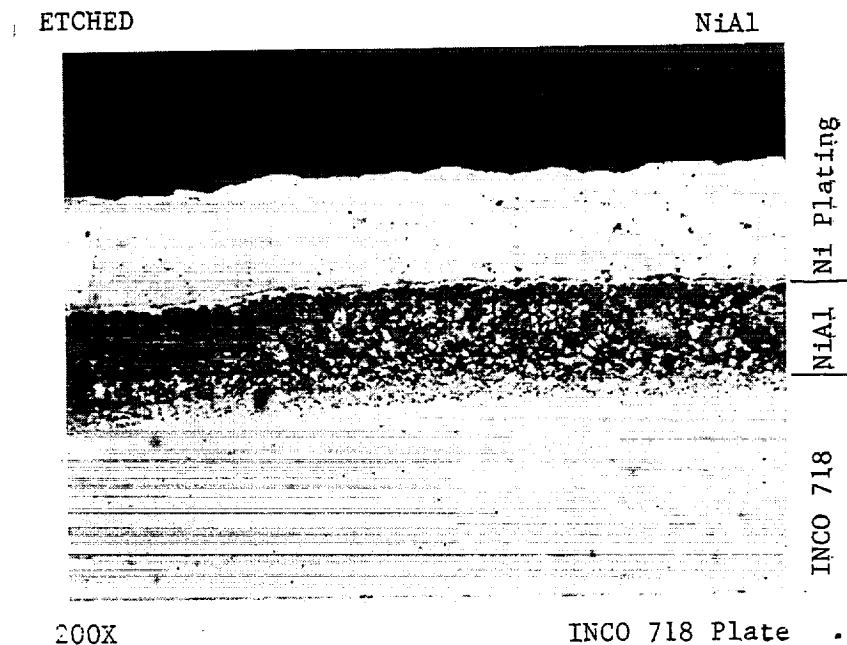
FIGURE 6. PHOTOMICROGRAPH NICKEL ALUMINIDE COATED INCO 718
PLATE WITH NICKEL PLATING STRIPES

**COATED BY CHROMALLOY RESEARCH
& TECHNOLOGY DIVISION FOR
MECHANICAL TECHNOLOGY, INC.
3 MILS**

**PLATED WITH 3 MILS, Ni-426 ELECTROLESS NICKEL
VACUUM FIRED AT 820°C, 4-6 HOURS**

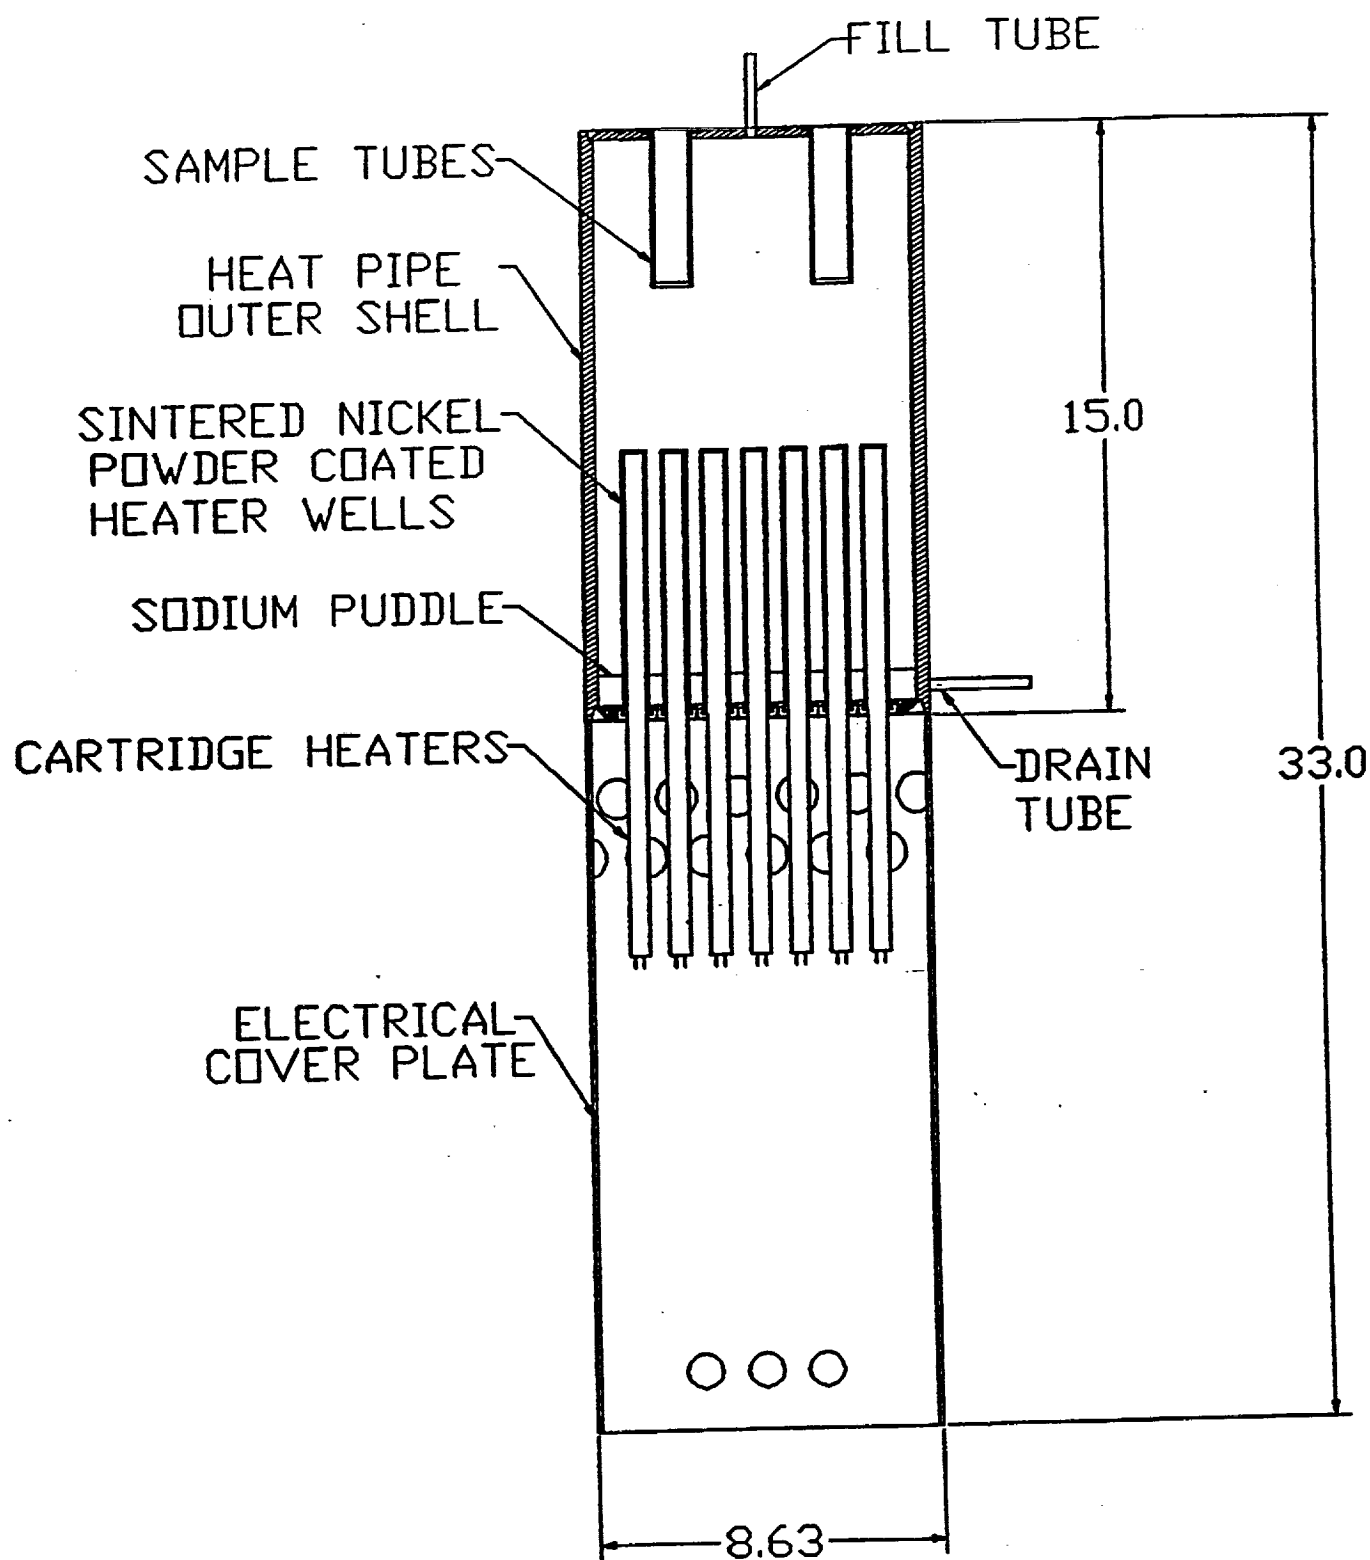
FIGURE 11. LAYOUT DRAWING OF THE SOLUBILITY CORROSION TEST HEAT PIPE (Dimensions in inches)

laboratory setting. A layout drawing of the selected design is shown in Figure 11. The evaporator section consists of 36, 1000 Watt cartridge heaters brazed into sintered nickel powder coated heater wells. The sodium fluid charge was selected to completely wet the sintered wick and to also cover the lower tube sheet to a depth of approximately 19 mm (.75"). The sodium working fluid is wicked up the length of the heater by capillary pressure generated in the sintered nickel wick structure. The sodium is evaporated from the heated surface and travels as a vapor to the condenser section consisting of the sample tubes welded into the heat pipe top endcap. Each of the sample tubes was fitted with a bayonet style gas gap calorimeter designed to extract the thermal power at the 25 W/cm² condensation heat flux.

The evaporator design is a variation of a number of heat pipes that Thermacore has supplied to Stirling engine manufacturers for laboratory testing of engines at full power conditions. The design of the nickel wick structure, 152.4 mm (6.0") long, 190.5 mm (.75") outer diameter, and 1.6 mm (.063") thickness was selected such that at full power (1000 Watts/heater), the safety factor for liquid pumping capability was 100% more than required. In other words, the wick structure was designed with a safety factor of 2 at the worst case operating conditions. In reality, the heaters are never operated at full power. In fact the heaters for this test vehicle were operated at only 40% of full power. Therefore, the effective wick design safety factor was approximately 5.

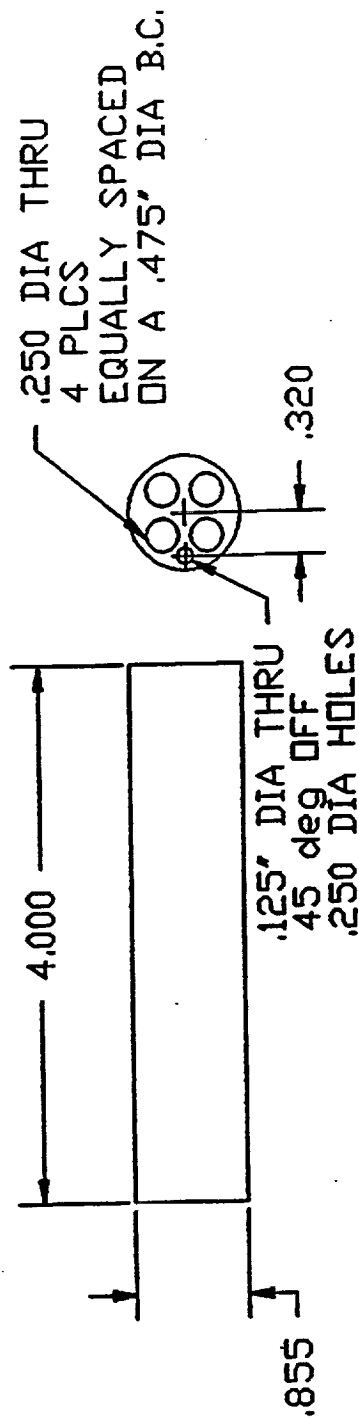
FIGURE 12. GAS GAP CALORIMETER FABRICATION DRAWING (Dimensions in inches)

CALORIMETER TUBE

NOTE: ON ONE END, MILL A POCKET CONNECTING HOLES 1&2 AND 3&4
ON THE OTHER END, MILL A POCKET CONNECTING HOLES 2&4
POCKET DEPTH SHOULD BE .25"

MATERIAL: 304 or 316 SS

In order to extract the thermal power and simulate the 25 W/cm² condensation heat flux, bayonet style gas gap calorimeters were designed. A gas gap calorimeter can be used to operate a heat pipe over a wide power range at a fixed operating temperature. The gas gap calorimeter

consists of two parts: the heat pipe condenser tube (in this application the sample tube) and the water calorimeter. In this application, the water calorimeter is placed inside the condenser tube with a known gap between the two parts.

The operation of a gas gap calorimeter is best understood by tracing the flow of thermal energy from the inside of the heat pipe to the water in the water calorimeter. The sodium vapor generated in the evaporator section condenses on the outer diameter of the sample tubes releasing its latent heat of vaporization. The thermal energy is transferred through the wall of the sample tube by conduction. Next, the energy is transferred across the gas gap by radiation and by conduction through the gas. By controlling the fraction of argon, a low thermal conductivity gas, and the fraction of helium, a high thermal conductivity gas, in the gas gap, the resistance to conduction across the gap can be modulated. The heat is then transferred through the wall of the water calorimeter by conduction and transferred by convection to the water flowing through the water calorimeter. The temperature rise of the water flowing through the calorimeter and the water flowrate are used to calculate the power extracted and the condensation heat flux.

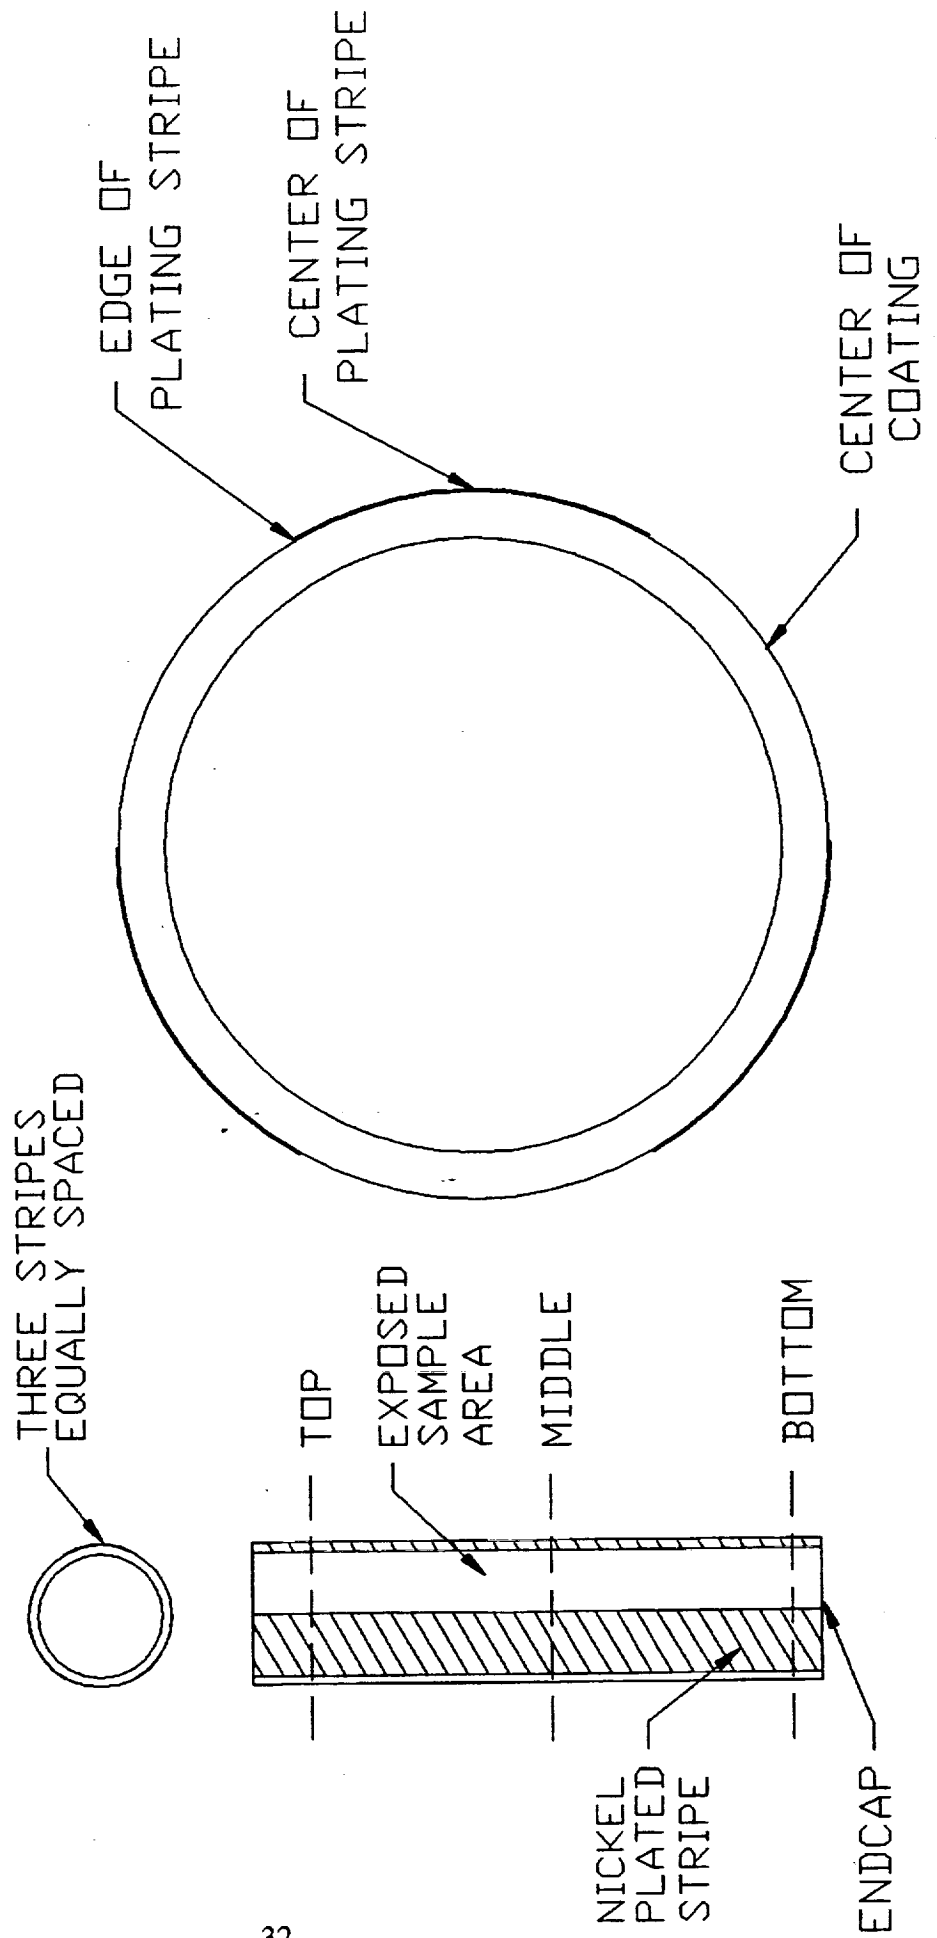
FIGURE 16. KEY FOR AXIAL AND CIRCUMFERENTIAL PHOTOMICROGRAPH LOCATIONS

photomicrographs was a three acid etch consisting of nitric acid, hydrochloric acid, and acetic acid. A small amount of cupric chloride was added to enhance the etchant's staining capability. Each of the above mentioned locations were photographed at three magnifications: 51, 100, and 200X. A complete set of photomicrographs is included as Appendix A. Figure 16 is a key of the axial and circumferential locations. Figure 19 presents the Appendix A photomicrograph labeling organization.

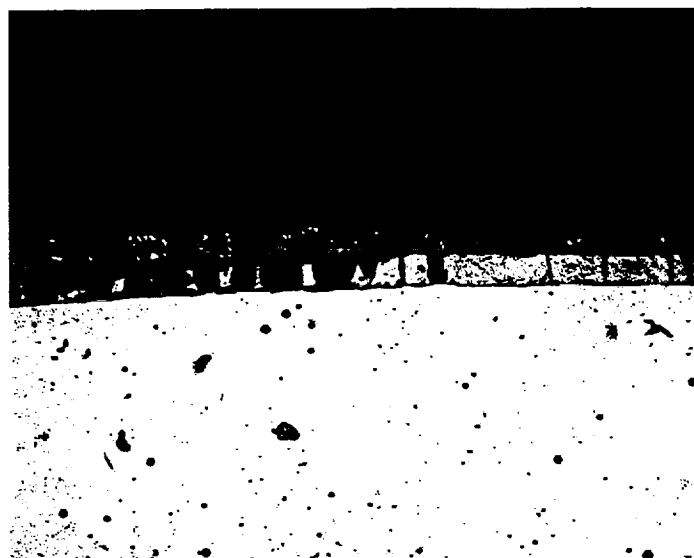
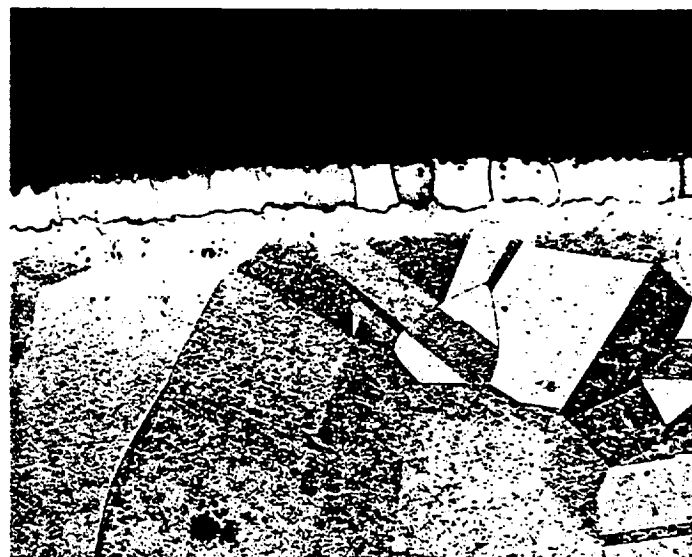
**FIGURE 17. PHOTOMICROGRAPH OF NICKEL ALUMINIDE COATED NICKEL 200
SAMPLE TUBE BEFORE AND AFTER 1000 HOUR TEST**

BEFORE 1000 HOUR CONDENSING SODIUM TEST

**AFTER 1000 HOUR AT 800°C SUBJECTED TO 25 W/cm²
CONDENSING HEAT FLUX WITH SODIUM**

2. Photomicrographs of the nickel aluminide coated Nickel 200 tubes showed less than .00254mm (.0001") corrosion from the 25 W/cm² condensing sodium flux at 800°C for 1000 hours. The resolution of the photomicrographs is better than .00254 mm (.0001").

As discussed in Section 2.3, the photomicrograph technique has a resolution of $2.5\text{ }\mu\text{m}$ (.0001") or better. For 200X photographs, .5 mm (.020") is equivalent to $2.5\text{ }\mu\text{m}$ (.0001") of actual. An example of the nickel aluminide coated sample tube after the 1000 hour test is shown in Figure 17 along with a picture of a nickel aluminide coated sample tube before the 1000 hour test. The 1000 hour test appears to have had no affect on the nickel aluminide coated tube. The conclusion is that there is essentially no visible solubility corrosion, which quantitatively means less than $2.5\text{ }\mu\text{m}$ (.0001") in 1000 hours. Figure 18 is a representative sample of the bare Nickel 200 sample tube. The Nickel 200 sample also shows no visible solubility corrosion, which quantitatively means less than $2.5\text{ }\mu\text{m}$ (.0001") per 1000 hours. If solubility corrosion had occurred, the Figure 18 (top) photomicrograph surface feature would appear similar to the superimposed dashed line.

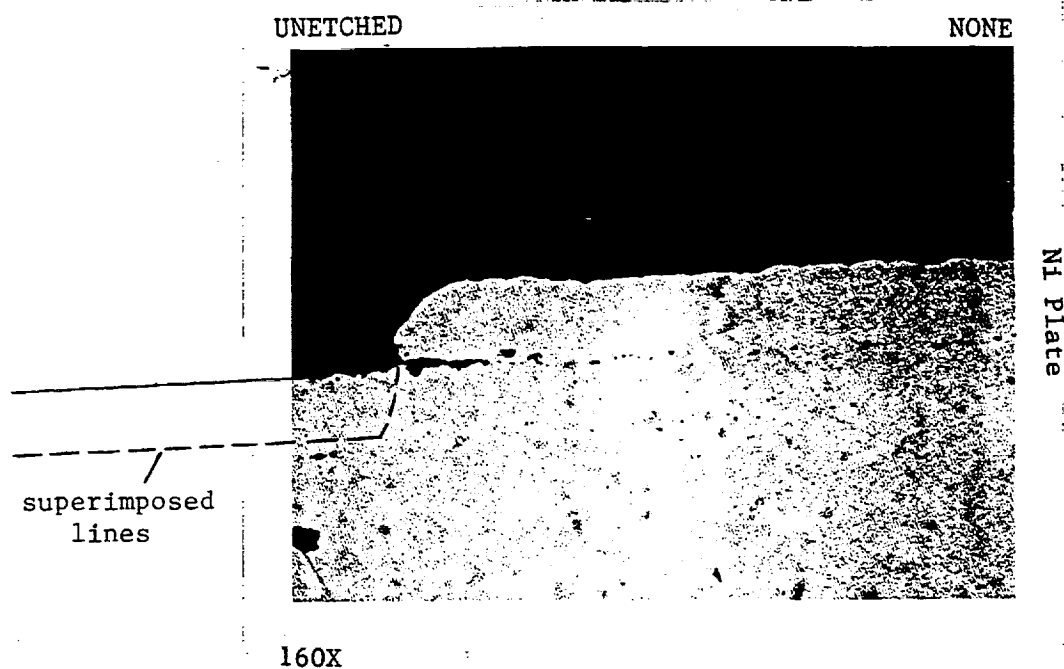
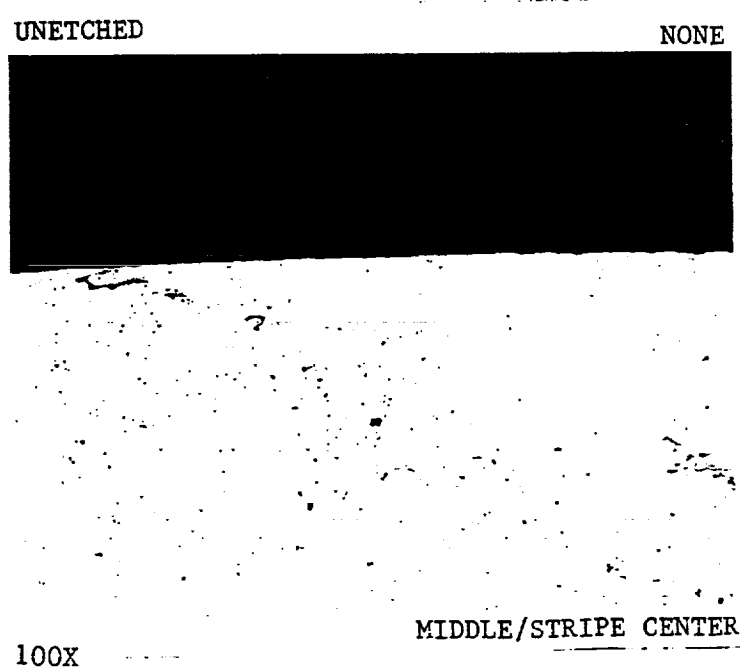
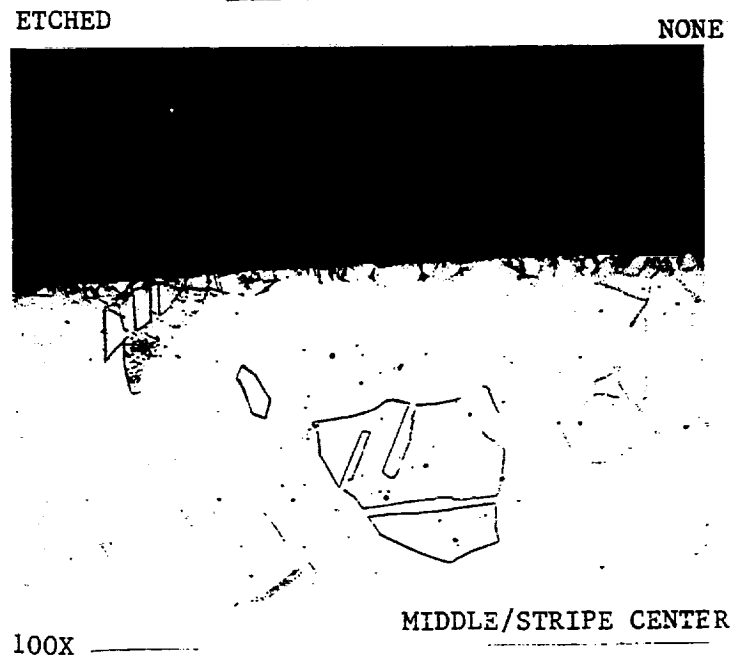
FIGURE 18. PHOTOMICROGRAPH OF NICKEL 200 SAMPLE TUBE BEFORE AND AFTER 1000 HOUR TEST

BEFORE 1000 HOUR CONDENSING SODIUM TEST

AFTER 1000 HOUR AT 800°C SUBJECTED TO A 25 W/cm² CONDENSING HEAT FLUX WITH SODIUM

3. Photomicrographs of the bare Nickel 200 tubes showed less than .00254 mm (.0001") corrosion from the 25 W/cm² condensing sodium flux at 800°C for 1000 hours. The resolution of the photomicrographs is better than .00254 mm (.0001").

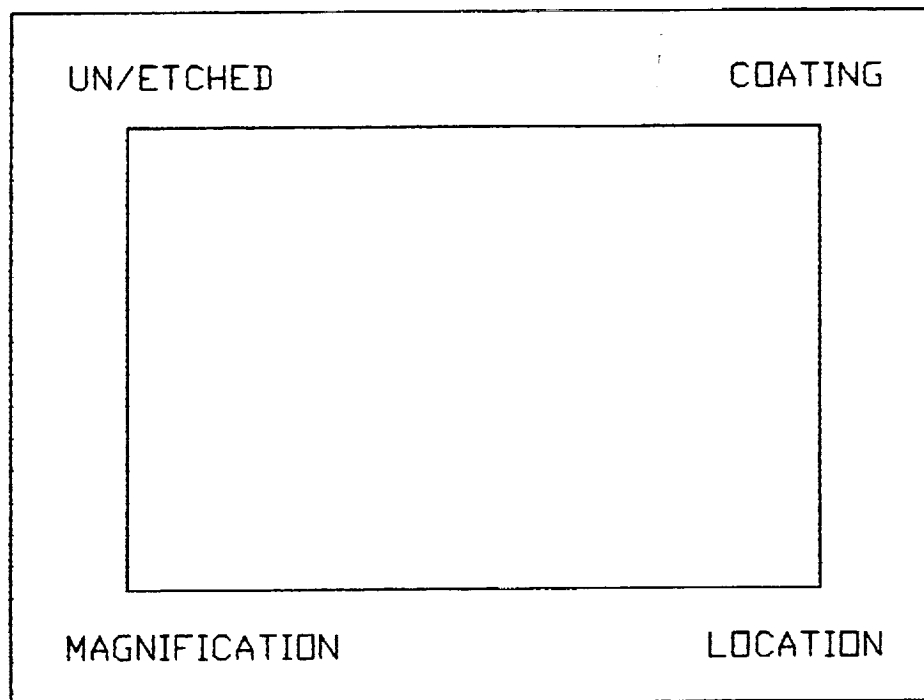
FIGURE 19. APPENDIX A PHOTOMICROGRAPH ORGANIZATION

UN/ETCHED = UNETCHED OR ETCHED SAMPLE PHOTOMICROGRAPHS

COATING = NONE OR NICKEL ALUMINIDE (NiAl)
